## SERVICE LETTER

Service Letter Number: 007

Subject: Wear Port Indicator Instructions

Applicability: 400 Series Dry Air Pumps

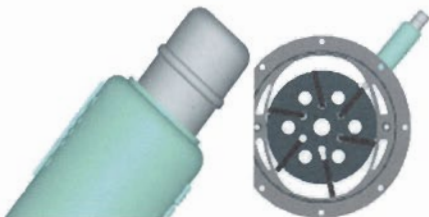
New Vane Indication

Vane still Good - Land not touching top of barrel

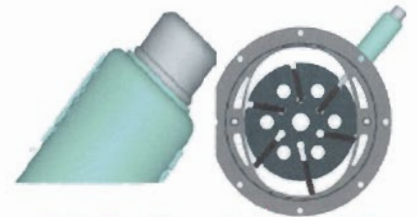
Land TOUCHING Barrel Vane at service limit - Replace Pump

Replace Pump if any vane is at it's service limit.
