Marvel-Schebler/Tillotson

SERVICE BULLETIN

#A2-78

SUBJECT: IMPROVED METHOD OF SEALING PUMP AND ECONOMIZER RODS TO REDUCE THROTTLE FRICTION ON MODEL HA SERIES CARBURETORS.

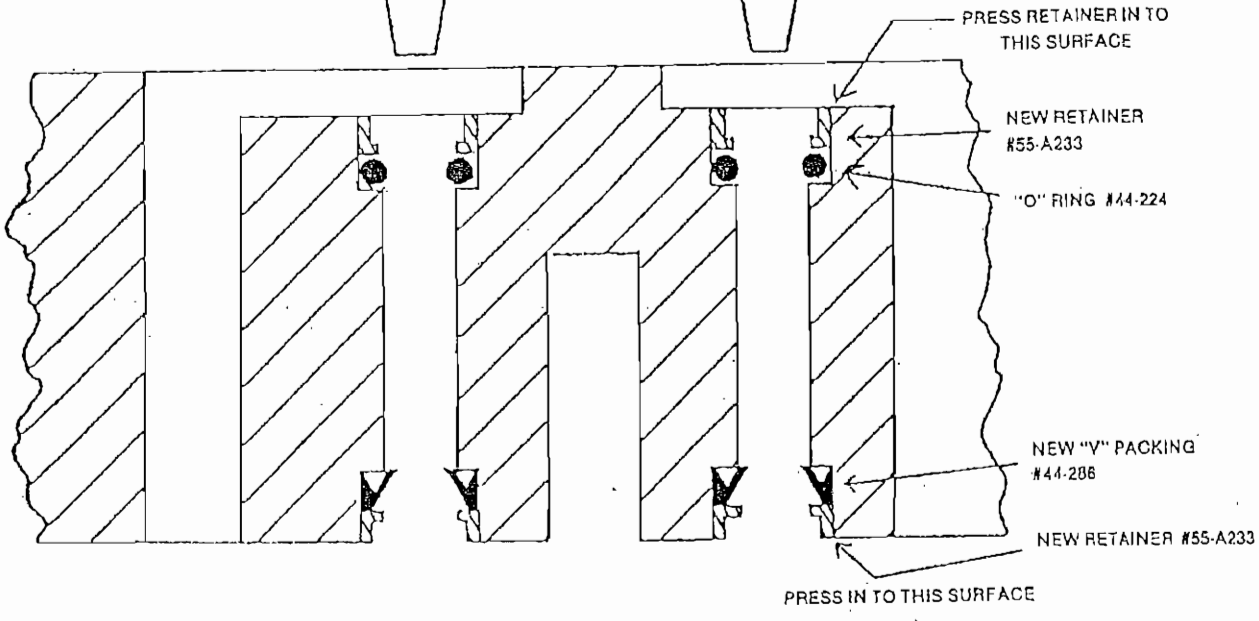
Some applications of Model HA carburetors have been reported to have a tight "throttle" condition where considerable force is required to open and close the throttle.

Kits contain the new polished rods, new "V" packings, "O" rings and retainers and an installation tool to protect packings during assembly.

Assemble in accordance with the following drawing. Use manual procedure to complete carburetor assembly.
