MARVEL-SCHEBLER DIVISION

SERVICE BULLETIN

#A5-67

SUBJECT: PUMP INLET CHECK VALVE REDESIGN

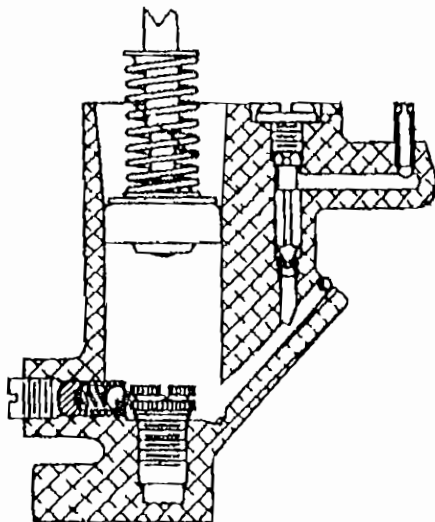
OLD STYLE (36-539)
KNURLED HEAD USED WITH BALL
SAFETY RATCHET

CAUTION - DO NOT INSTALL THE OLD KNURLED HEAD TYPE IN A NEW STYLE BOWL WHICH DOES NOT HAVE PROVISION FOR THE BALL SAFETY RATCHET.

WE HAVE JUST STARTED TO PRODUCE BOWLS WITHOUT PROVISION FOR THE BALL SAFETY AND, AS THERE ARE FEW SERVICE BOWL ASSEMBLIES SOLD, YOU WILL HAVE NO TROUBLE USING UP YOUR INVENTORY OF THE OLD STYLE 36-539 IN NORMAL SERVICE AND REPAIR.

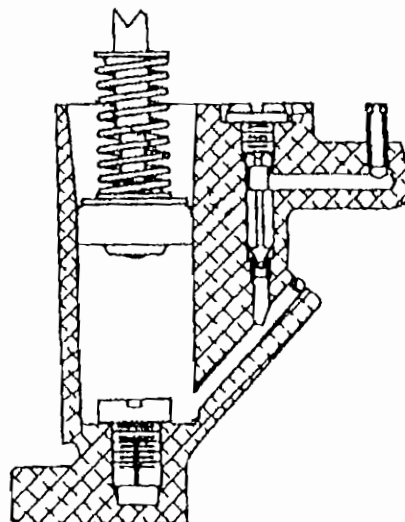
NEW STYLE (36-587) ✓
PLAIN HEAD WITH LONGLOC THREAD
INSERT - NO SAFETY RATCHET REQUIRED

THE NEW LONGLOC STYLE WILL REPLACE THE OLD IN ALL CASES.
