Volare' Carburetors, LLC
125 Piedmont Avenue
Gibsonville, N.C. 27249, USA

Service Bulletin: SB-11
Revision: Original
Date: June 17th, 2009

SUBJECT – UNAPPROVED REPAIR PRACTICE

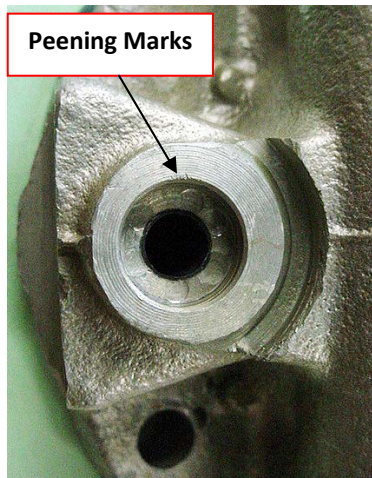
Fact: Peening the area around the bearing bore causes the mixture shaft loads to bear on small, upset metal projections which will wear away quickly. Thus, the repair will be short lived. Additionally, an airtight seal between the mixture control shaft and the throttle body is imperative. If the seal is compromised and outside (ambient) air enters the float bowl, an excessively rich fuel/air mixture will occur. The rough surface can prevent the necessary airtight seal.

Examples of unauthorized peening of the mixture shaft bore are shown in Figures 1 & 2 on page 2, (Fig. 1 bottom view, Fig. 2 top view). Figure 3 shows a properly repaired mixture shaft bore. The factory can make such repairs. If the mixture shaft bearing bore has inadequate metal remaining, contact Volare' to have the bore properly repaired.

Figure 2: Peened Example

4. **Compliance:** At the next carburetor disassembly or sooner if an excessively rich mixture is experienced:
 - a. Examine the mixture shaft bearing bore and area around it. If unauthorized repairs have been accomplished, the mixture shaft bearing bore is oversized, or the sealing surfaces are damaged, send the carburetor to Volare for repair.

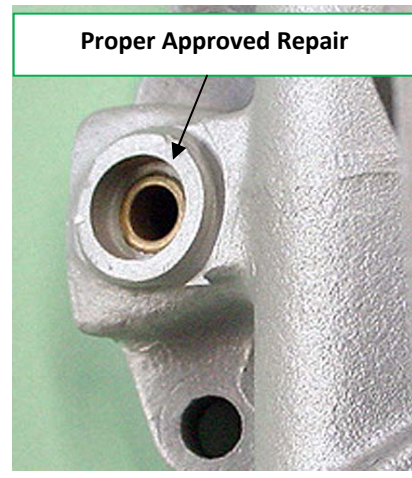
Figure 3: Proper Bushed Repair
