Volare Carburetors LLC

FLIGHT SAFETY Service Bulletin

Bulletin No. SB-3

Subject: HA-6 ACCELERATOR PUMP PLUNGER

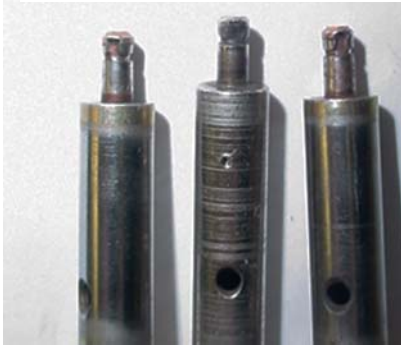
Fig 1

3. **Background:** The attached photos show pump stems having severe wear above the retaining clip groove (Figs 1 & 2). Normal stems (Figs 4 & 5) are shown for reference. Volare is not aware of instances of such advanced wear in stems manufactured by Volare. The rough surface-finish (center, Fig. 1) and wide clip grooves (outer stems, Fig. 3,) are not similar to design specifications of stems manufactured by Volare.

Note: Rough Surface finish

Three bad Accelerator Pump Stems.

b. Within 25 hours of operation after the date of this FLIGHT SAFETY Service Bulletin or prior to March 15, 2009, whichever comes first, remove the bowl cover and inspect the accelerator pump stem. No discernable wear in the clip groove is permitted. Replace any stem exhibiting a rough surface finish, a non-standard groove/head configuration and/or wear in the clip groove, however slight, with a NEW plunger assembly (part number is carburetor model dependent), a NEW pump rod guide, part number 88-92 and a NEW clip, part number 78-A295 supplied by Volare on or after March 4, 2008.

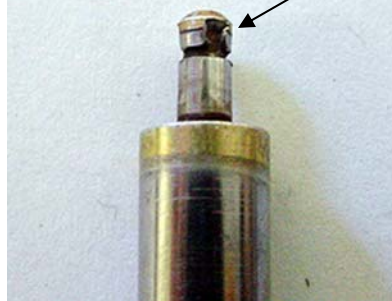
Fig 2

Note: Wear from Retaining

Clip

Close up showing wear from Retaining Clip.

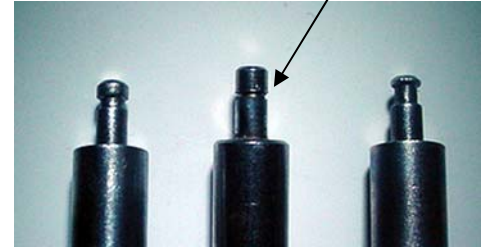
Fig 3

Center Stem is Good

Machining differences among different stems

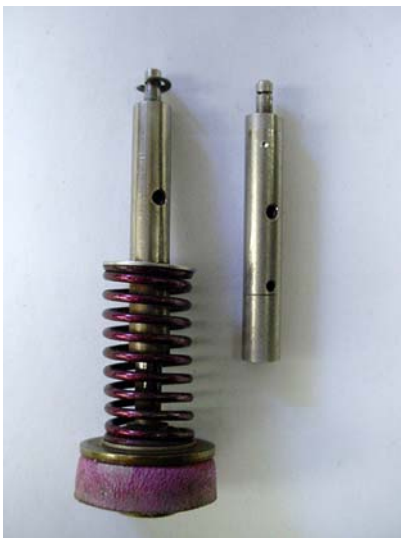
Fig 4

Two good accelerator pump Stems, one with clip still installed.

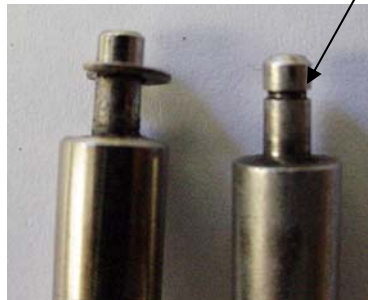
Fig 5

Note: Retaining Clip groove is pristine

Close up detailing lack of wear on good stems.
