**Volare' Carburetors, LLC**

**Service Bulletin: SB-6**

Revision: Original  
Date: June 17<sup>th</sup>, 2009

**SUBJECT – MIXTURE CONTROL STOP WEAR – HA-6 TYPE CARBURETORS.**

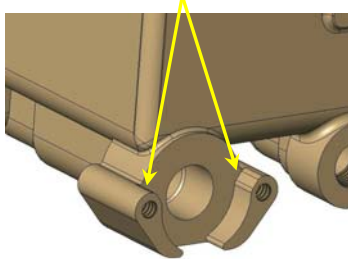
**FIGURE 4**

- c. Examine the mixture valve stops for wear in the areas shown in Figures 4 & 5. The maximum permissible wear depth is .046 inch.

**Check for wear on BODY stops**  
EACH Side, not to exceed .046" deep

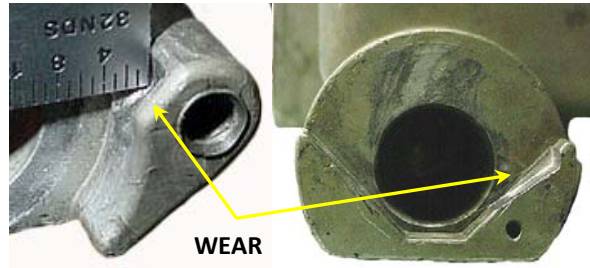
**FIGURE 5**

**Current & earlier fuel mixture stop designs showing excessive wear examples**

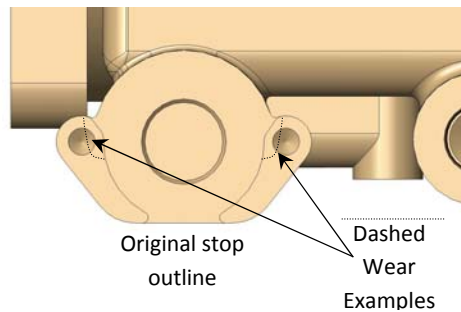
**FIGURE 6**

- e. Use a depth indicator, scale or other suitable measuring device to determine the depth of the wear, if any, of the stops. If the wear exceeds .046 inch below the 'original outline' of the part as shown in Figure 6, the carburetor must be submitted to Volare for repair, as in Figure 7.
