## **Volare Carburetors, LLC**

## ***Service Bulletin (SB-4)***

### **Subject: BOWL CLEARANCE – MA- SERIES CARBURETORS**

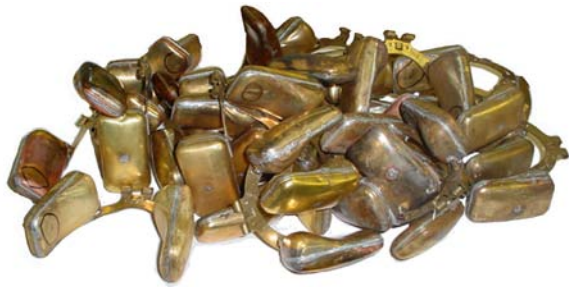
**Fig. 1**

1. **Reasons:** **Warning:** **Failure to follow this advice may result in engine malfunction, damage, injury or death.** Reports of sticking, leaking and/or worn floats have been received, see Figure 1. The specified float/bowl clearance **MUST** exist to ensure proper operation.

**Floats with Rubbing Wear – FEB 2009**

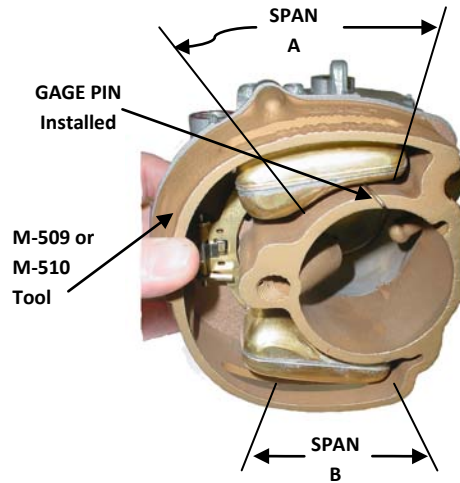
**Fig. 2**

With the clearance tool M-510 used with the (MA-3, MA-4 series) or M-509 used with the (MA-5, MA-6, MA-4-5 Series) in place, orient the carburetor body with one pontoon uppermost, see Figure 2. Check the clearance between the float pontoon and the bowl wall. A .081 inch gage pin (models MA-2, MA-3 & MA-4), or a .051 gage pin (models MA-4-5, MA-4-5AA, MA-5, MA-5AA, MA-6 and MA-6AA) must pass between the lower surface of the upper pontoon and the throttle bore wall and between the lower surface of the lower pontoon and the lower bowl wall without touching either pontoon. Reorient the carburetor so that the other pontoon is uppermost, see Figure 3. Repeat the clearance check. If, as the gage pin is moved along between the float and the bowl wall the gage pin contacts either pontoon, float clearance is inadequate and the float assembly must be replaced.

**Carb Orientation 1, Check Spans A & B**

Install new parts as necessary. Torque and safety the cover screws and test the carburetor in accordance with instructions contained in the appropriate Carburetor Service Manual (MSAFSM) and Instructions E-1000 and E1002, appropriate to the model. Note: Instructions E-1000 and E1002 apply only to the installation of solid blue epoxy floats. **The float clearance requirements in this Service Bulletin apply to all Volare carburetors to which this bulletin is applicable, i.e., carburetors equipped with brass floats, regardless of the manufacturer of the float and MUST be adhered to.** *This Service Bulletin is not applicable to carburetors equipped with solid, blue epoxy floats, Volare part numbers 30-862 and 30-864.*

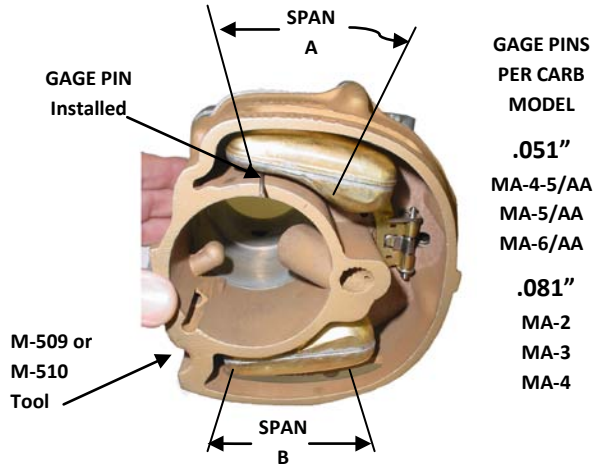
**Fig. 3**

**Carb Orientation 2, Check Spans A & B**

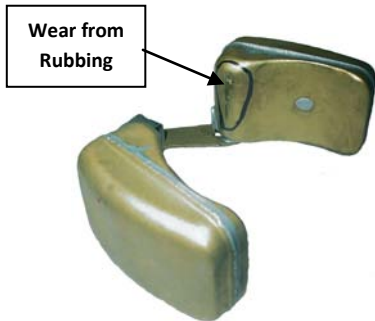
**Fig. 5**

**Example: Wear from Rubbing on Small MA Float**

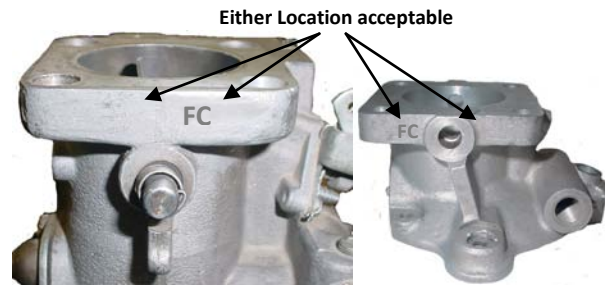
**Fig. 6**

5. **Identification/Marking:** Upon completion of this Flight Safety Service Bulletin, stamp the letters "FC" ( $\frac{1}{8}$  inch tall (nominal) characters) on the flange adjacent to the throttle shaft, see Figure 6.

**Conformance with this SB-4 'FC' Stamp Locations**
