**AERO ACCESSORIES, INC.
SERVICE BULLETIN**

SERVICE BULLETIN: SB-010

SUBJECT: DIAPHRAGM FUEL PUMP LEVER DAMAGE

APPLICABILITY: DIAPHRAGM FUEL PUMPS

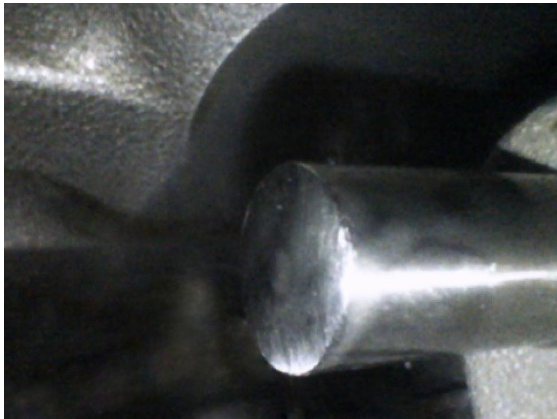
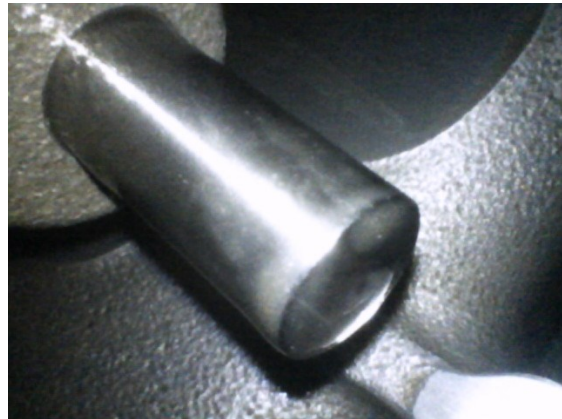
- a. Photo 1 shows an example of a damaged pump lever. Photo 2 shows a pump lever exhibiting normal wear. Note that normal wear appears as a localized shiny spot near the center of the pump lever’s pushrod pad and does not exhibit scratches, displacement of metal, or worn away metal. Photo 3 shows the end of a damaged pushrod. Note the worn, chipped, scratched, rounded end of the pushrod. Note further that in this example, scalloping is evident around the pushrod’s perimeter. Lesser damaged rods may not exhibit all these damage signatures. Photo 4 shows the end of a pushrod exhibiting normal wear. Note that a normally worn and serviceable pushrod contacts the lever in the approximate center one third (approximately) of the pushrod’s end diameter, as highlighted in photo 5, and that the outer portions of the pushrod’s end surface show no sign of contacting the pump’s lever. In this normally worn example, there is no deformation, scalloping, chipping etc. of the pushrod’s end and the majority of the rod’s original machining marks remain intact.

Photo – 3
Damaged Push Rod

- b. If any damage is observed – DO NOT INSTALL a fuel pump on the engine until a thorough investigation of the fuel pump drive train, including the pushrod, the hole in the accessory case that guides the pushrod, and the eccentric that drives the pushrod, is carried out in accordance with the engine manufacturer’s instructions and the engine is determined to be in serviceable condition.

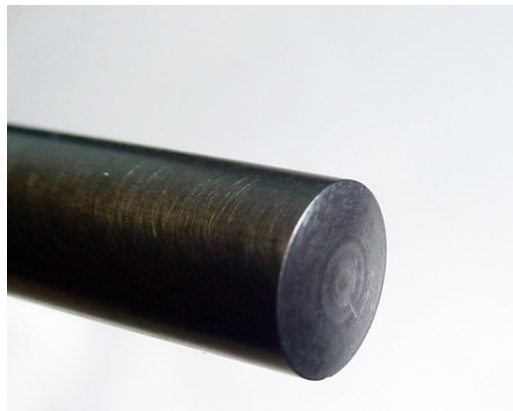
Photo – 4
Push Rod Exhibiting Normal Wear

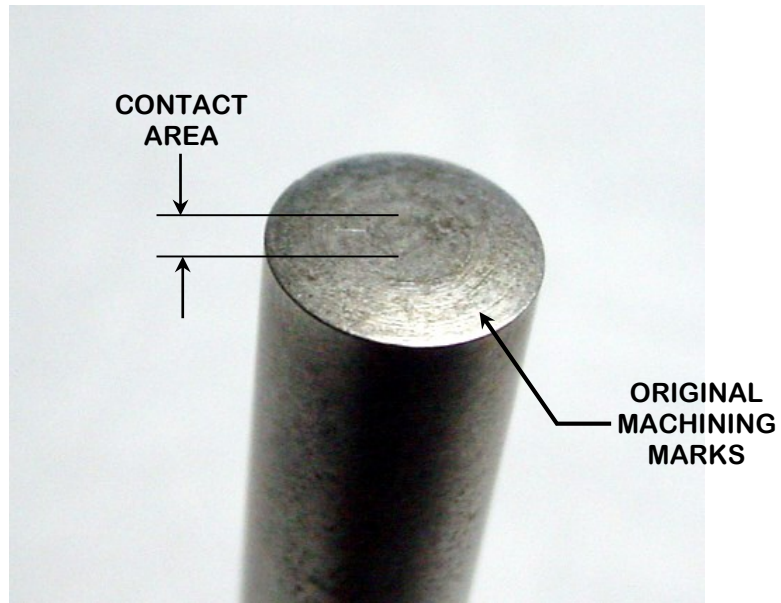
Photo – 5
Push Rod Exhibiting Normal Wear

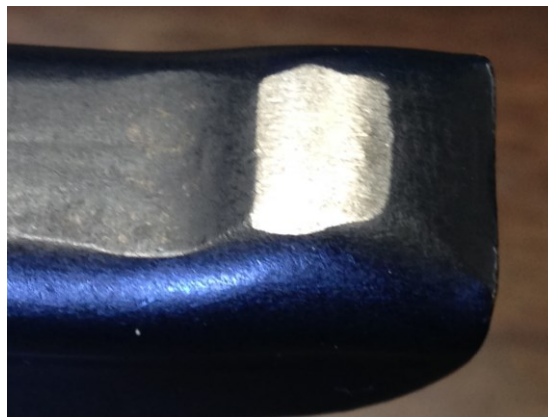
Photo – 6
Pump Lever from 62B Series Pump
Exhibiting Abnormal Wear
