Marvel-Schebler/Tillotson

SERVICE BULLETIN

#A2-78

SUBJECT: IMPROVED METHOD OF SEALING PUMP AND ECONOMIZER RODS TO REDUCE THROTTLE FRICTION ON MODEL HA SERIES CARBURETORS.

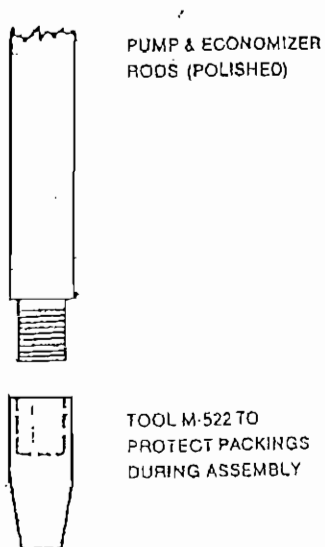
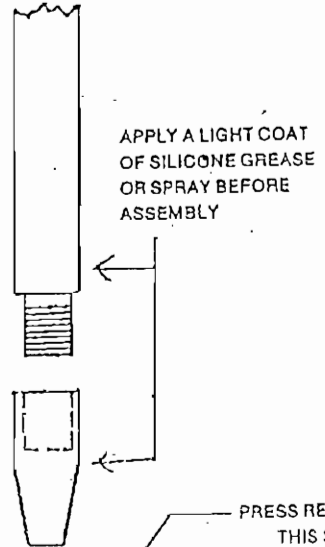
We have reduced the force to move the throttle by changing the sealing design of the accelerator pump and economizer rods and an improved finish on the rods using an electro-chemical polishing procedure.

Kits contain the new polished rods, new "V" packings, "O" rings and retainers and an installation tool to protect packings during assembly.

Assemble in accordance with the following drawing. Use manual procedure to complete carburetor assembly.
